**Hurricane Katrina: Damage Assessment of Power Infrastructure For
Distribution, Telecommunication, and Backup**

August 2006

Technical Report CEME-TR-06-05, Grainger Center for Electric Machinery and
Electromechanics, University of Illinois at Urbana-Champaign

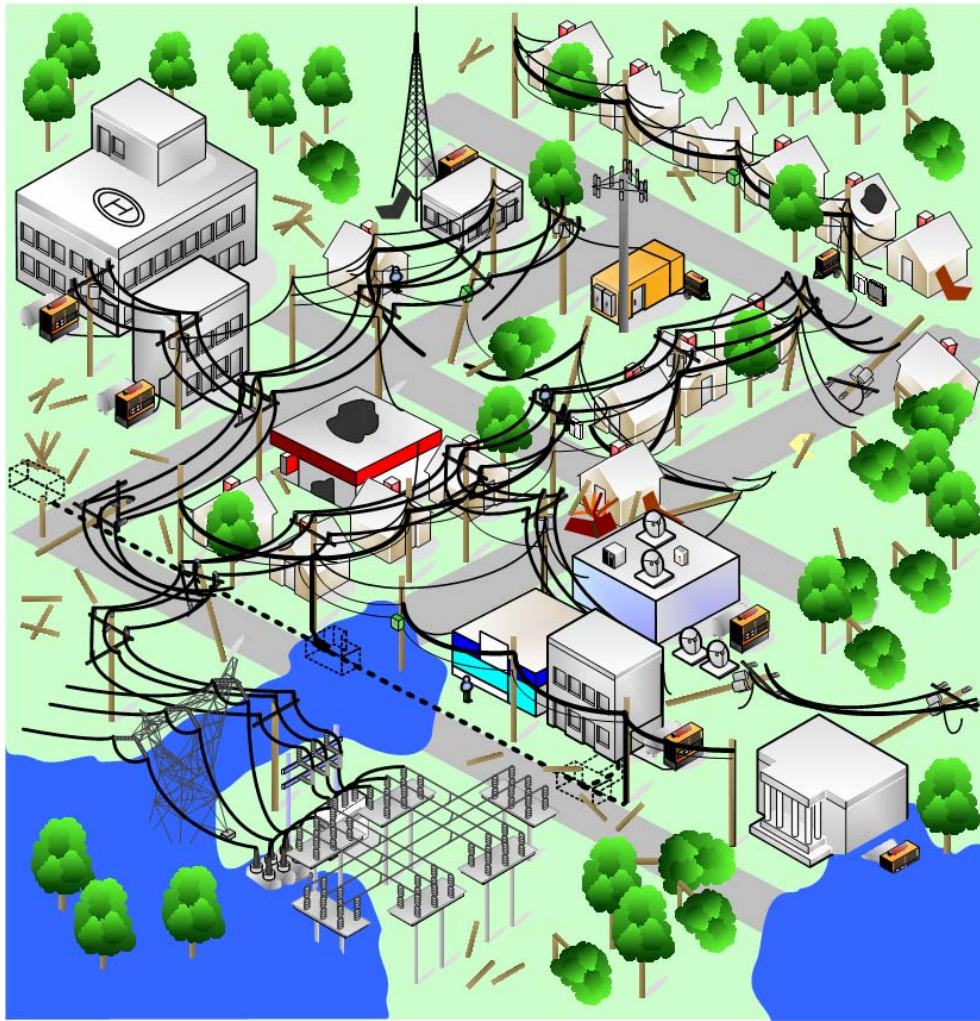
Fig. 2.16. Example of typical damage that a hurricane can cause in a town

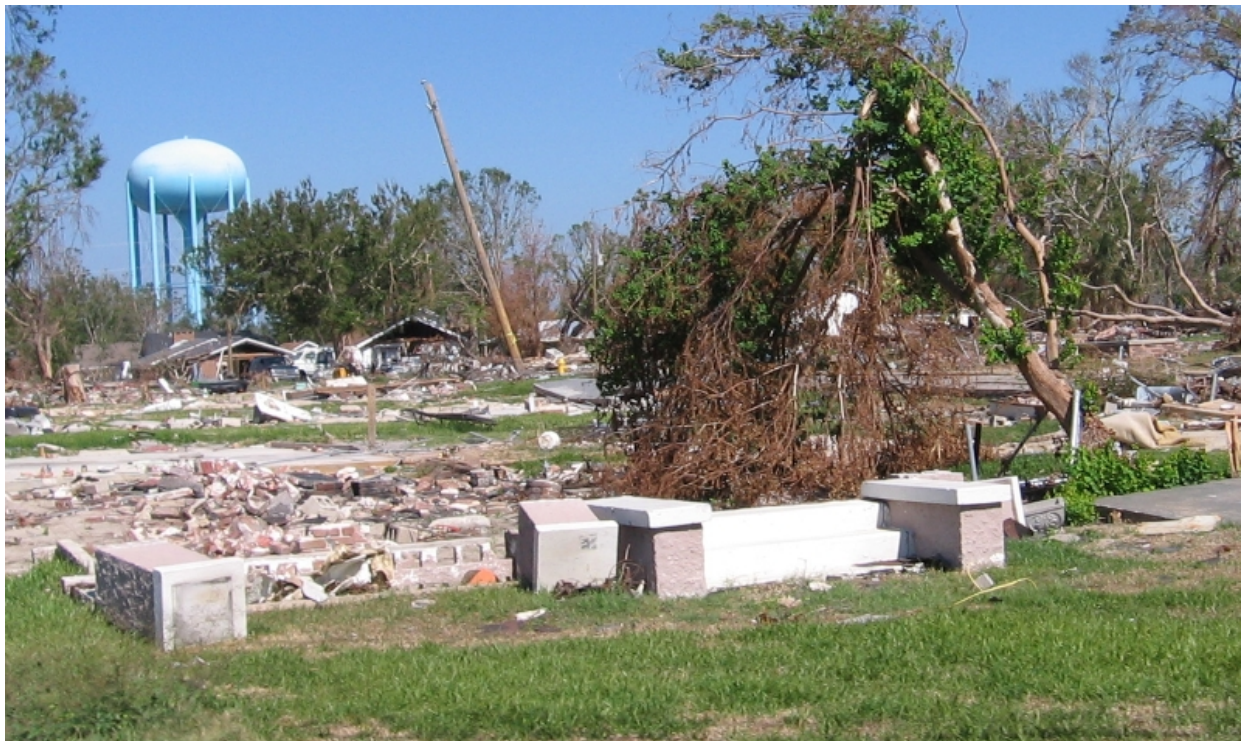
Fig. 3.1. Severe destruction in Biloxi, MS

Electrical and communication networks use common elements in their distribution infrastructure. Figs. 3.1-3.22 show damage typical to the common infrastructure of electrical and communication networks observed during the site survey. Even though the damage to these elements was severe, it was usually limited to specific areas of the affected region. For example, Figs. 3.1 and 3.2 show extensive damage to both the residences and the entire infrastructure in Biloxi. The same destruction is depicted in Point A La Hache (Figs. 3.3 and 3.4) and Delacroix (Fig. 3.5). However, areas a few hundred meters away were not so heavily damaged, as Figs. 3.6-3.11 attest. Since the damage caused to the outside plant was limited to specific areas, it can not be explained how outages in communication networks were so widespread. In addition, although the damage in Figs. 3.1-3.6 is severe, it is relatively easy to fix, as shown in Fig. 3.12. Thus, long durations of service loss in many CO areas cannot be justified by this damage.

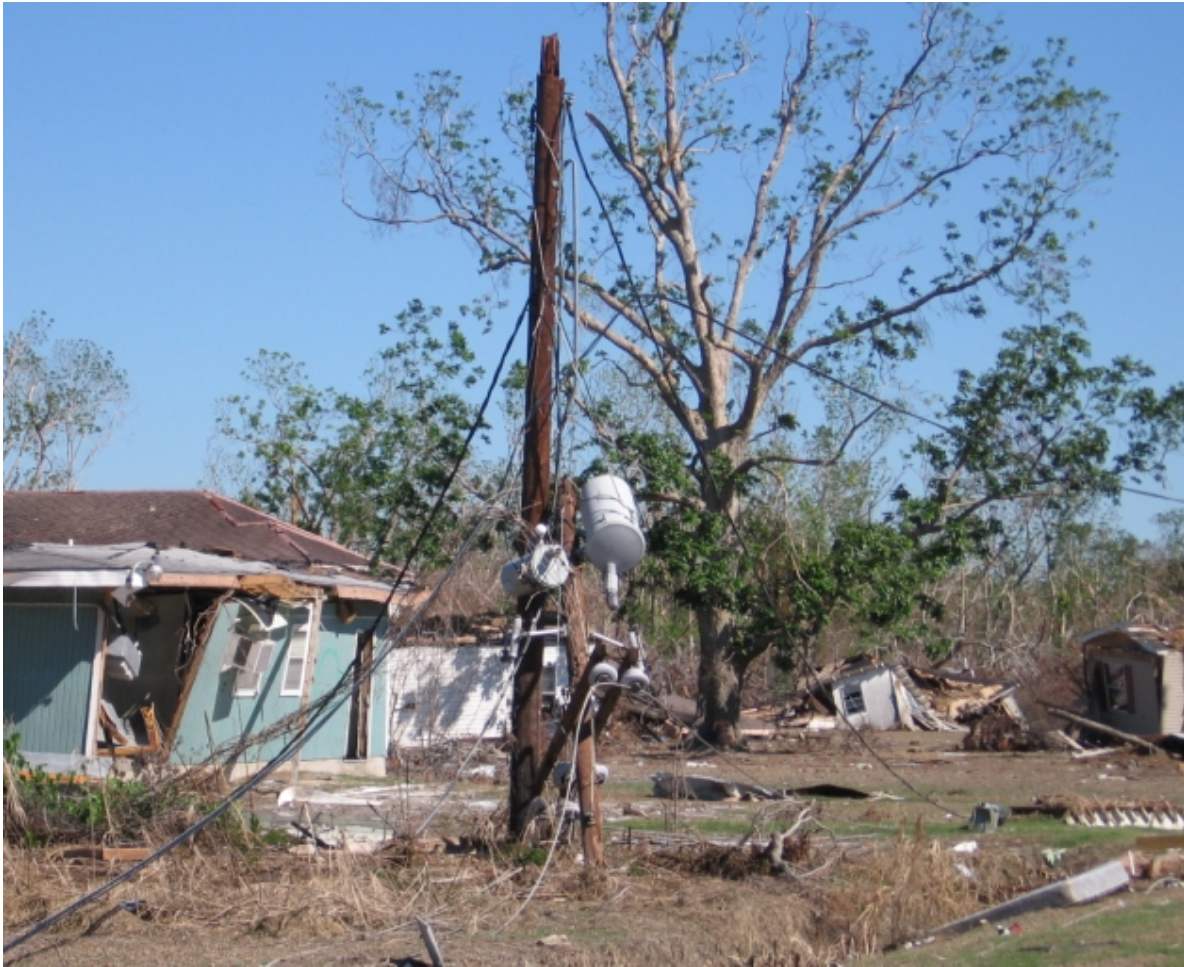
Fig. 3.3. Severe structural damage to houses and a broken pole with distribution transformer and telecom outside plant cables in Point A La Hache, LA

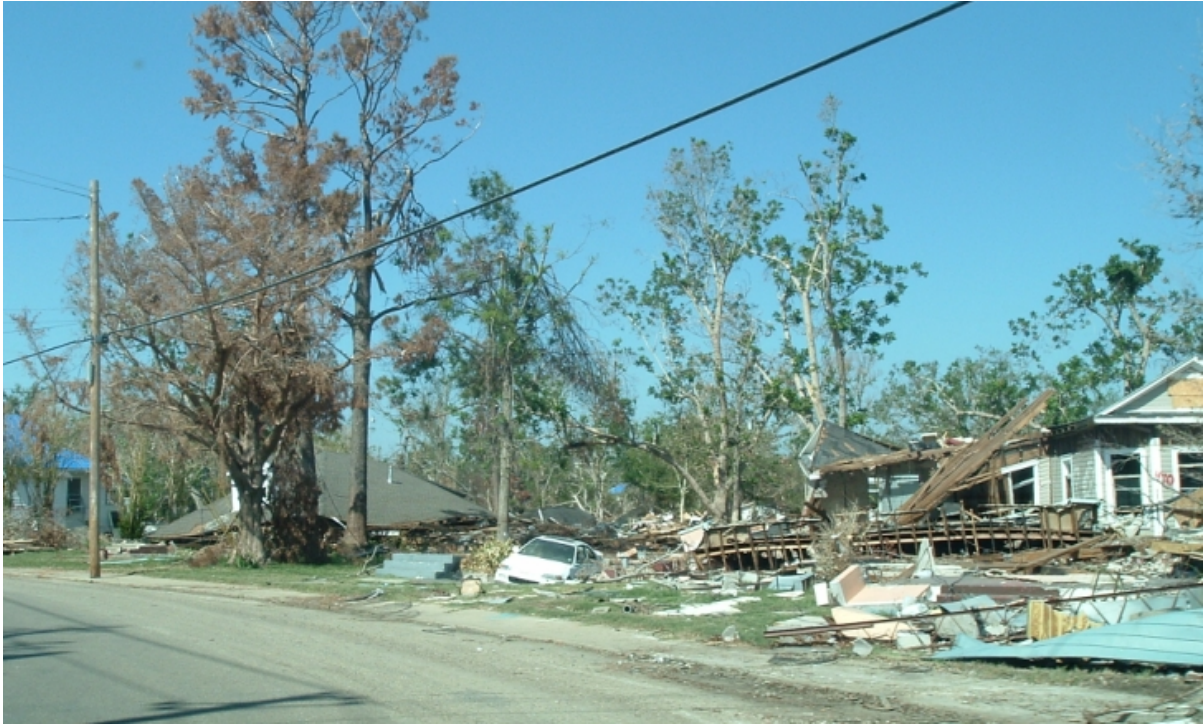
Fig. 3.6. Severe damage to houses but light outside plant damage in Biloxi, MS

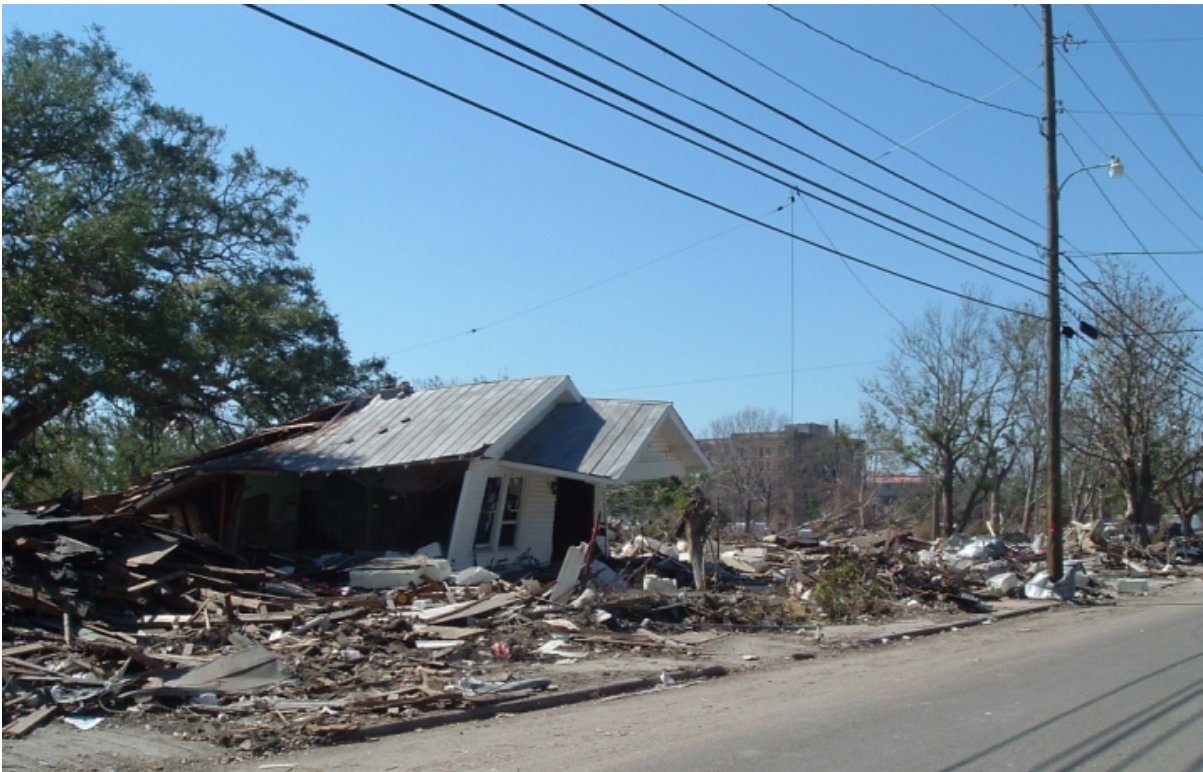
Fig. 3.7. Severe residential damage; none to electrical and PSTN distribution cables in Biloxi, MS

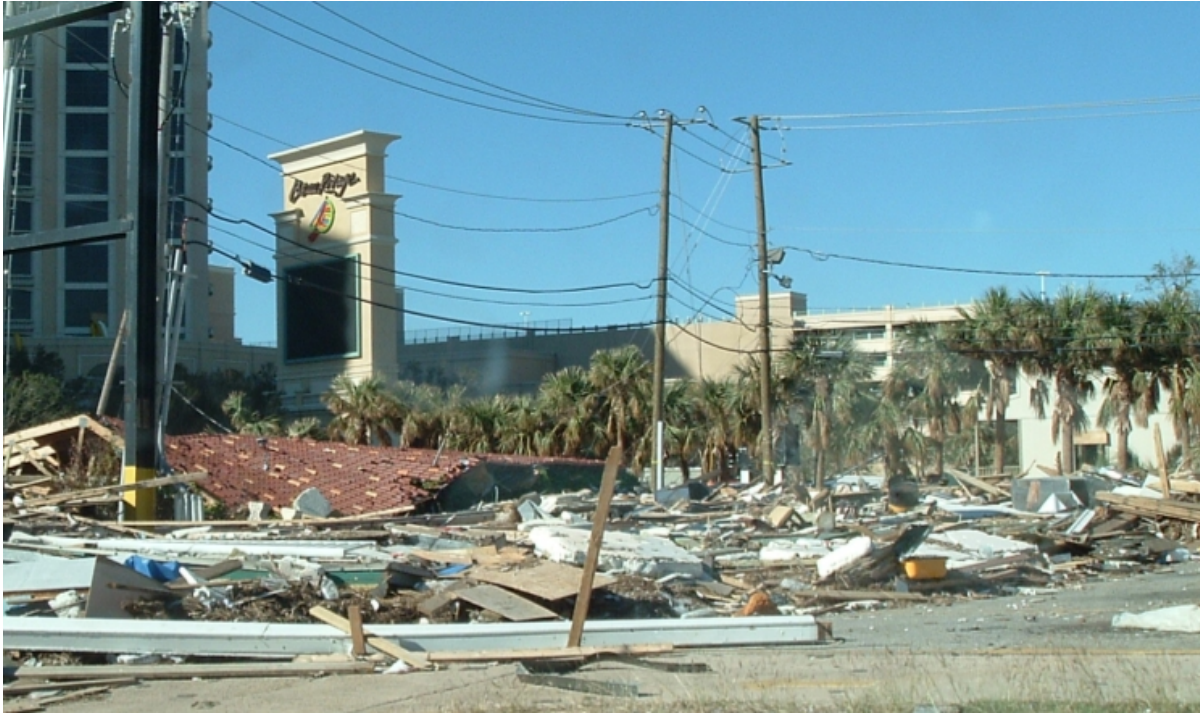
Fig. 3.8. Light damage to poles amid total destruction to buildings in Biloxi, MS

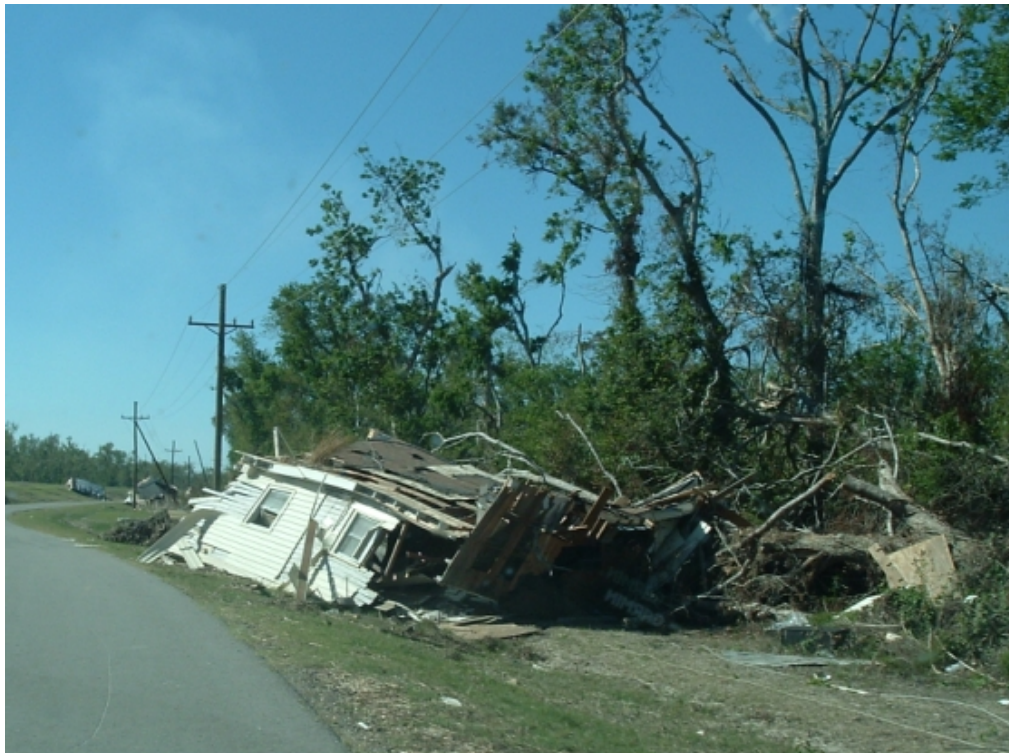
Fig. 3.9. Total destruction to houses but light damage to electrical infrastructure near Point A La Hache, LA

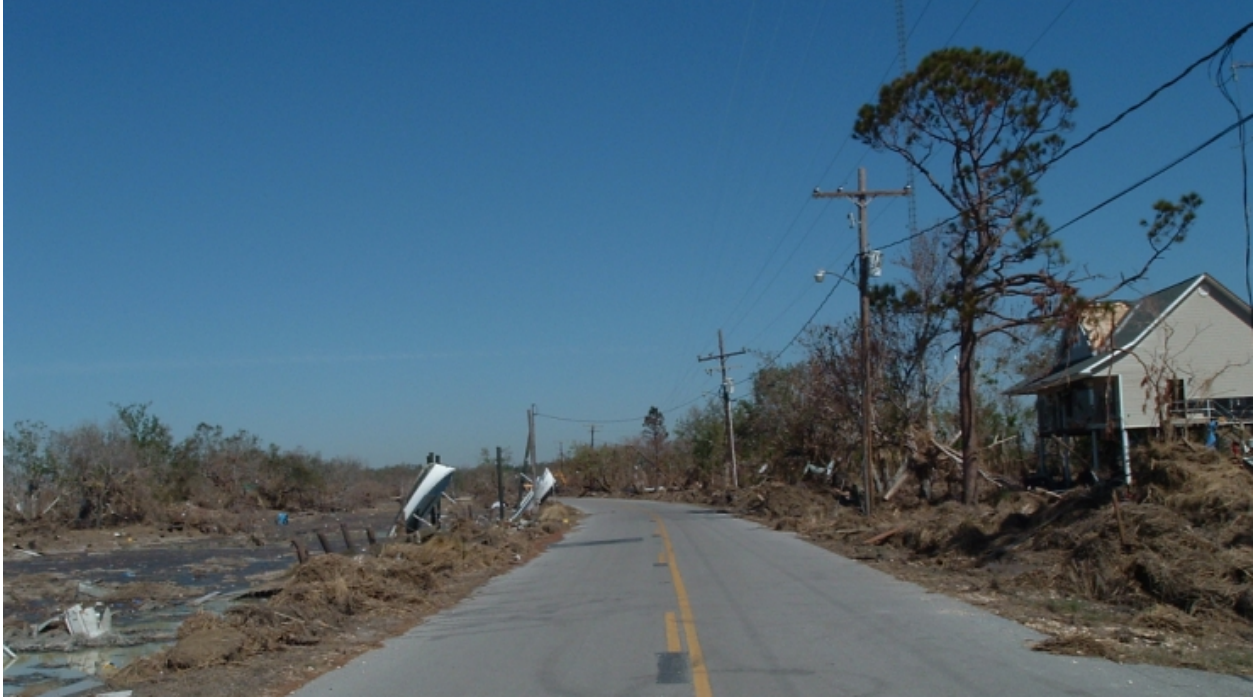
Fig. 3.10. Severe damage to construction but light damage to electrical and communication networks in Delacroix

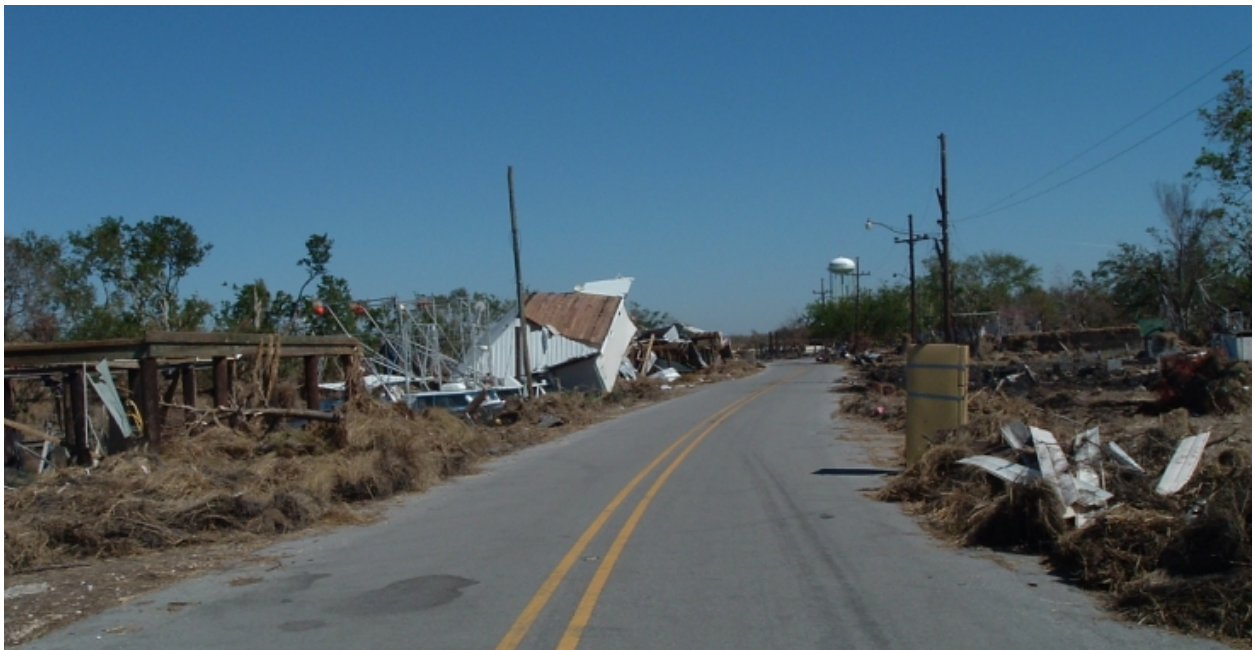
Fig. 3.11. Severe damage to construction but light damage to electrical and communication networks in Delacroix, LA

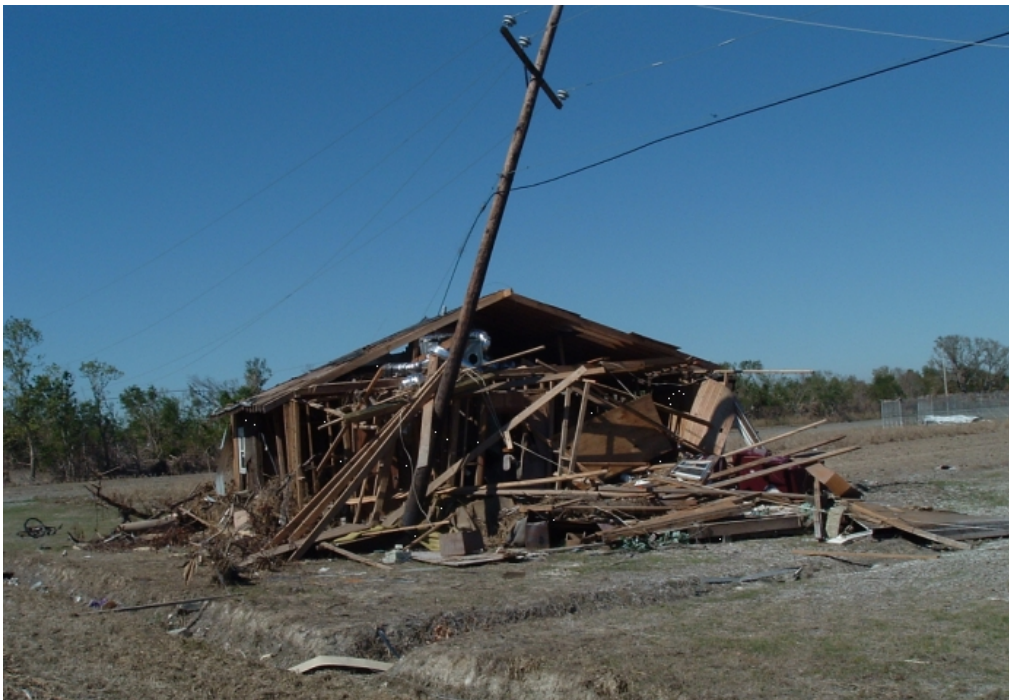
In some areas, the infrastructure was damaged by houses, loosed from their foundations by the storm surge, floating until they hit a pole, as in Fig. 3.13. Yet, in similar cases, presented in Figs. 3.14-3.17, boats and houses that floated away did not damage the infrastructure.

Fig. 3.13. House crashed on a pole on Highway 15, LA

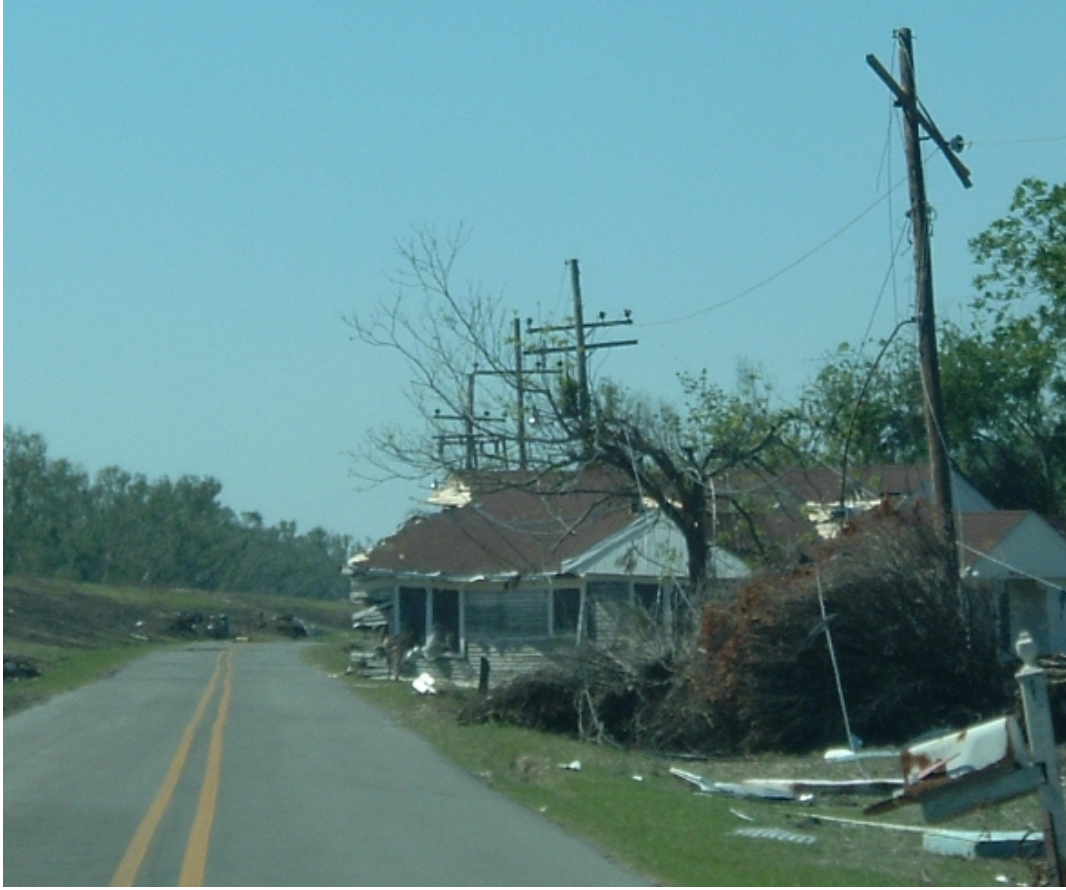
Fig. 3.14. Damaged pole and hanging wires on Highway 15, LA

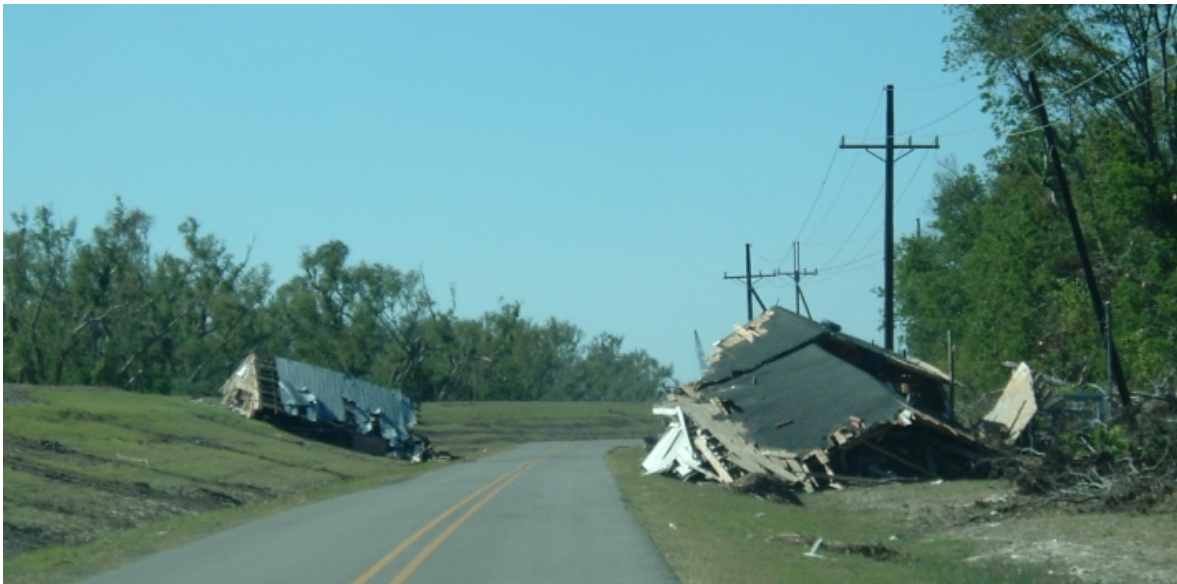
Fig. 3.15. Crashed house on a pole on Highway 15, LA

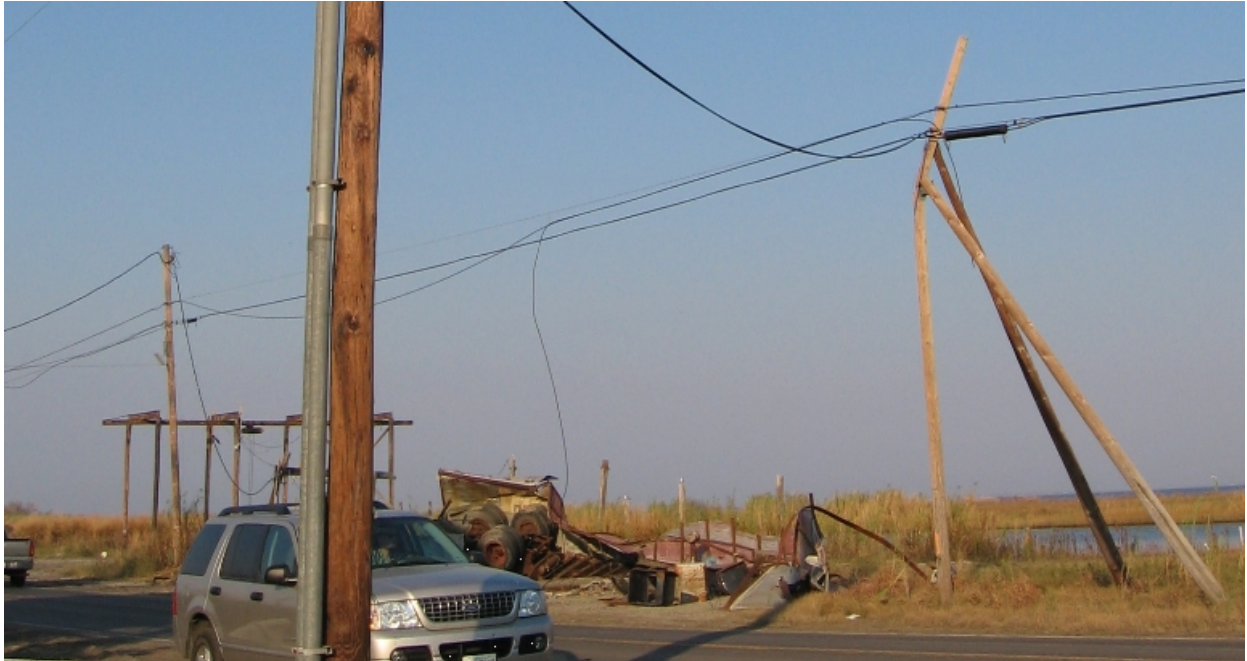
Scattered damage, as shown in Figs. 3.18-3.22, was encountered during the site survey in most of the area affected by Hurricane Katrina. Although this damage was not severe and was relatively simple to repair, being dispersed in a large area, it demanded considerable resources that, otherwise, may had been used to restore more seriously damaged zones. This damage affected only a small number of subscribers and was not the cause for the extended and severe loss of communication in the storm's aftermath. Critical outages were related to other causes including destruction of centralized communication nodes, such as COs, and electrical power failures. These will be discussed in the following sections.

Fig. 3.18. Damaged line on Route 11 south of Lake Pontchartrain, LA

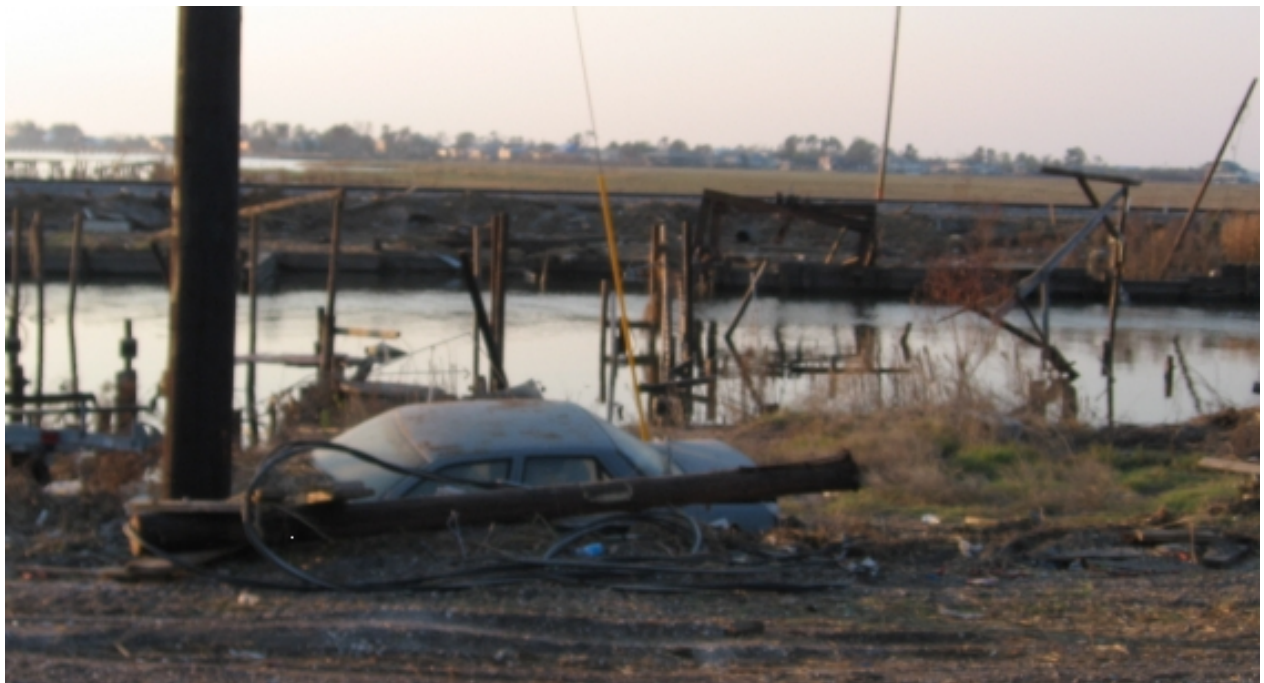
Fig. 3.19. Broken pole and remains of telephone distribution cable in Slidell, LA

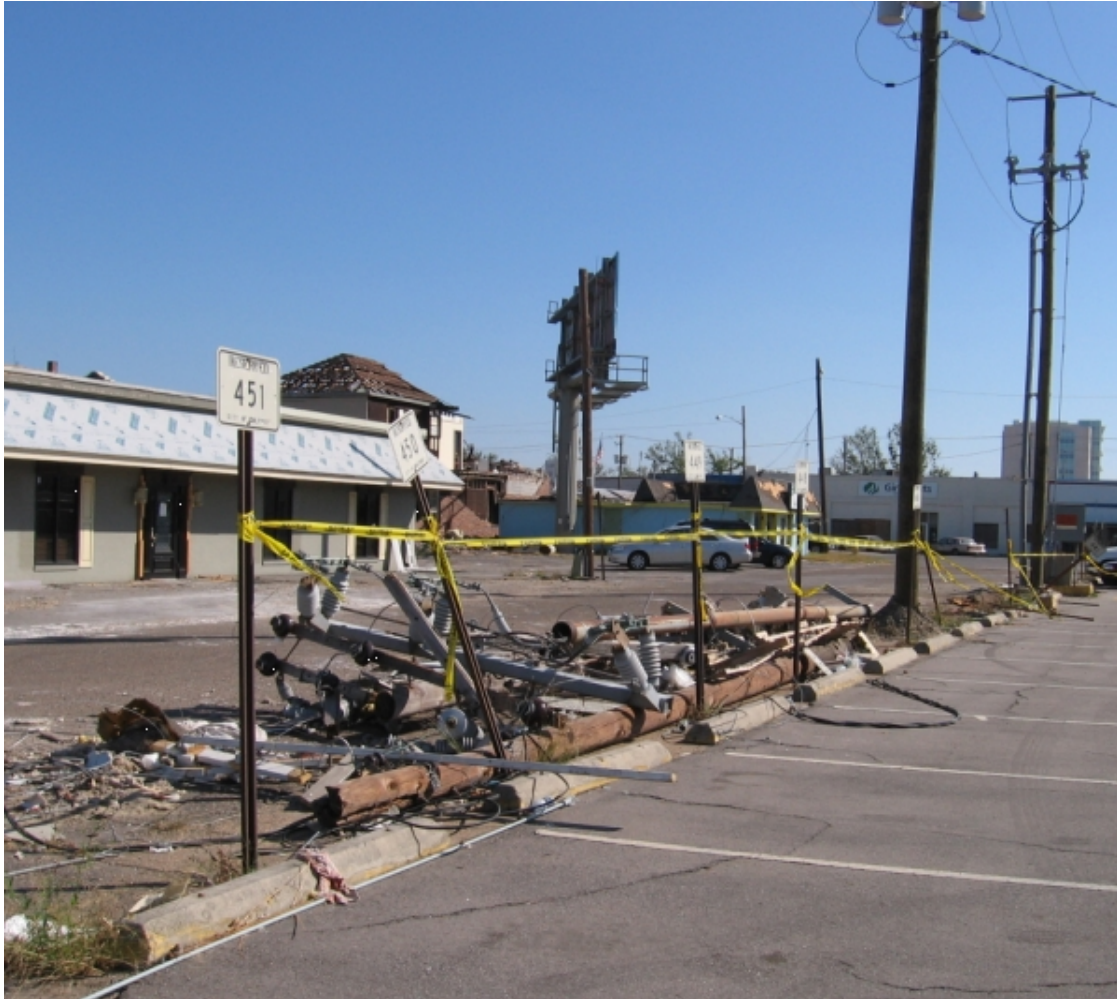
Fig. 3.20. Broken electrical pole in Biloxi, MS

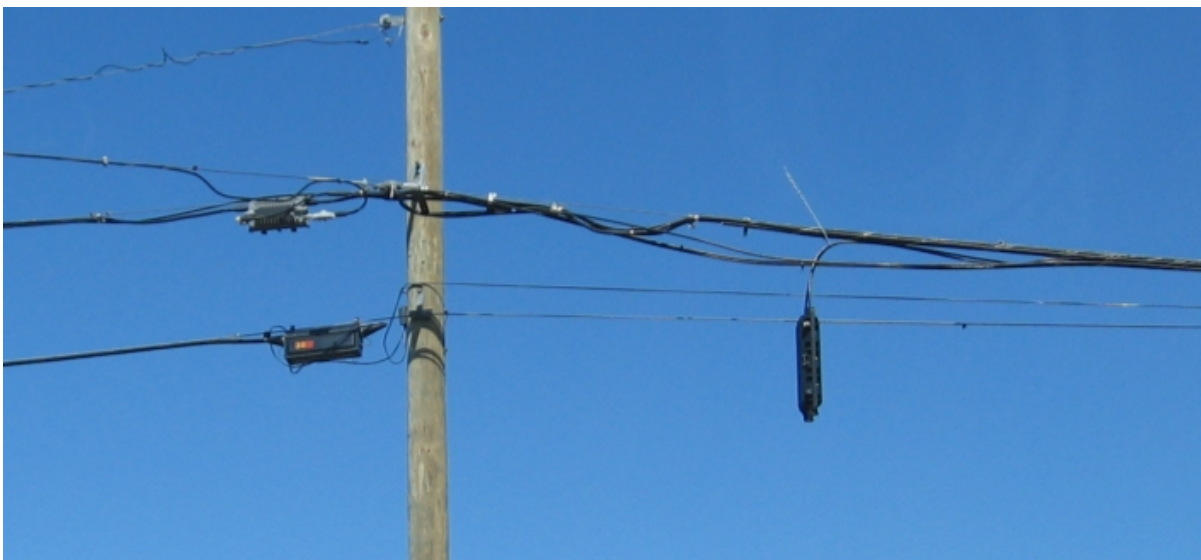
Fig. 3.21. Damaged CATV fiber-optic cable

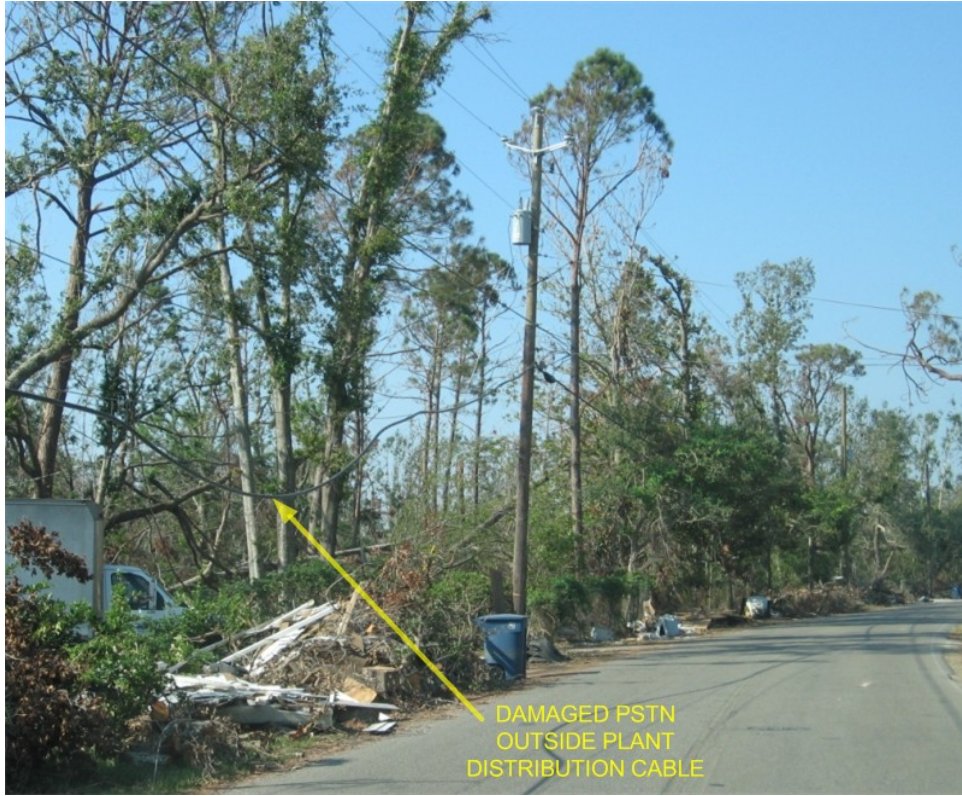
Fig. 3.22. Hanging damaged PSTN outside plant distribution cable

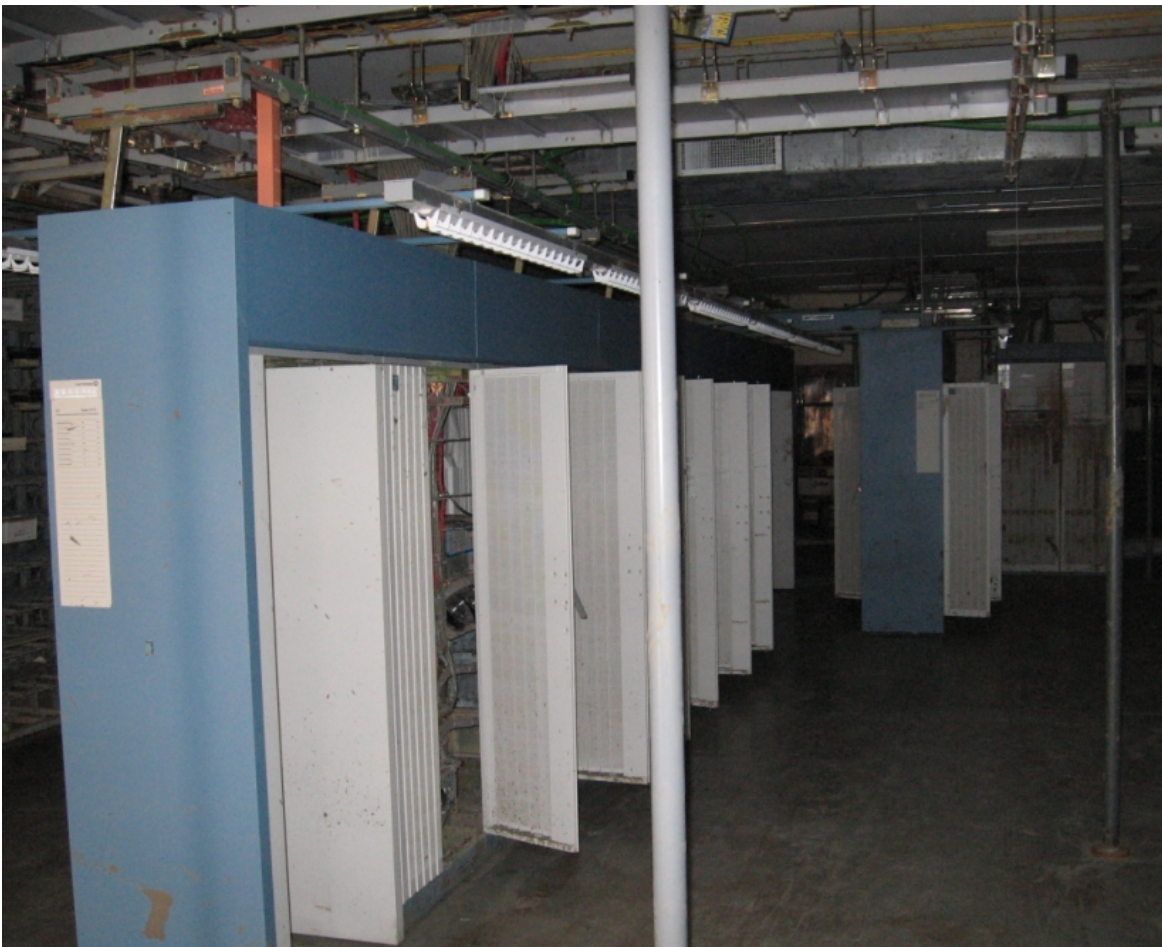
Fig. 4.1. Damaged switch (left). The rectifier bay is in the background, MDF on the left behind the switch. Notice the debris on the cable-racks.

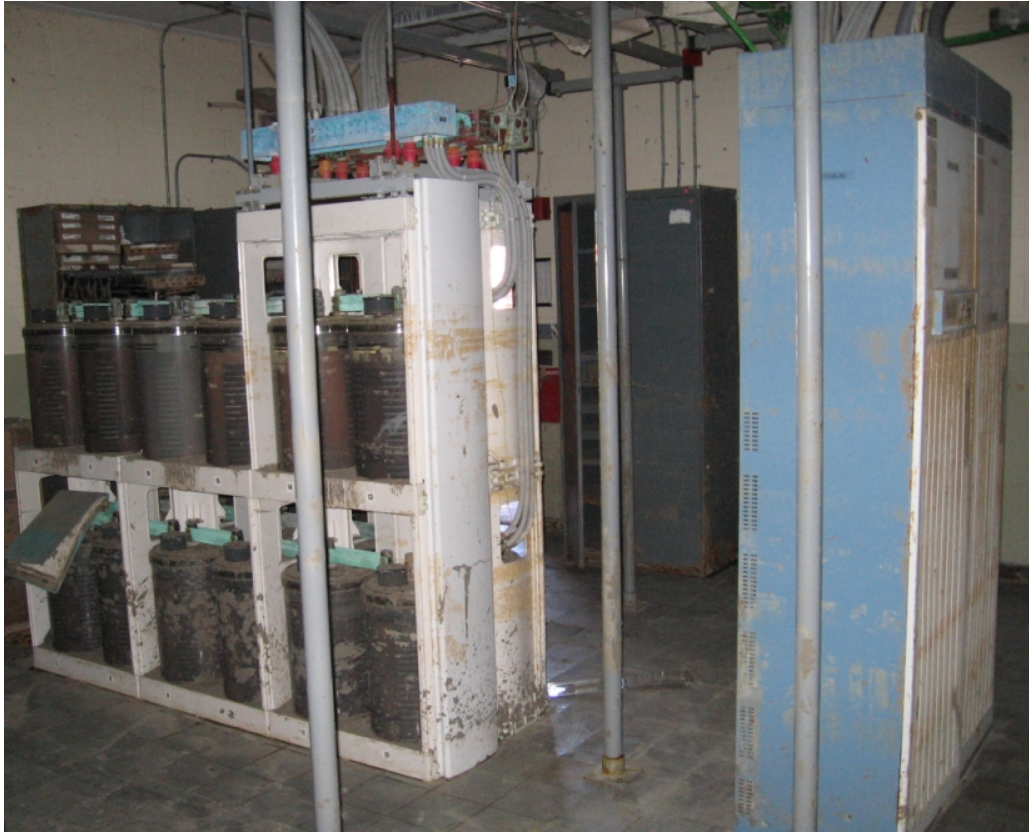
Fig. 4.6. Batteries on the left and rectifier bays on the right, both covered with mud

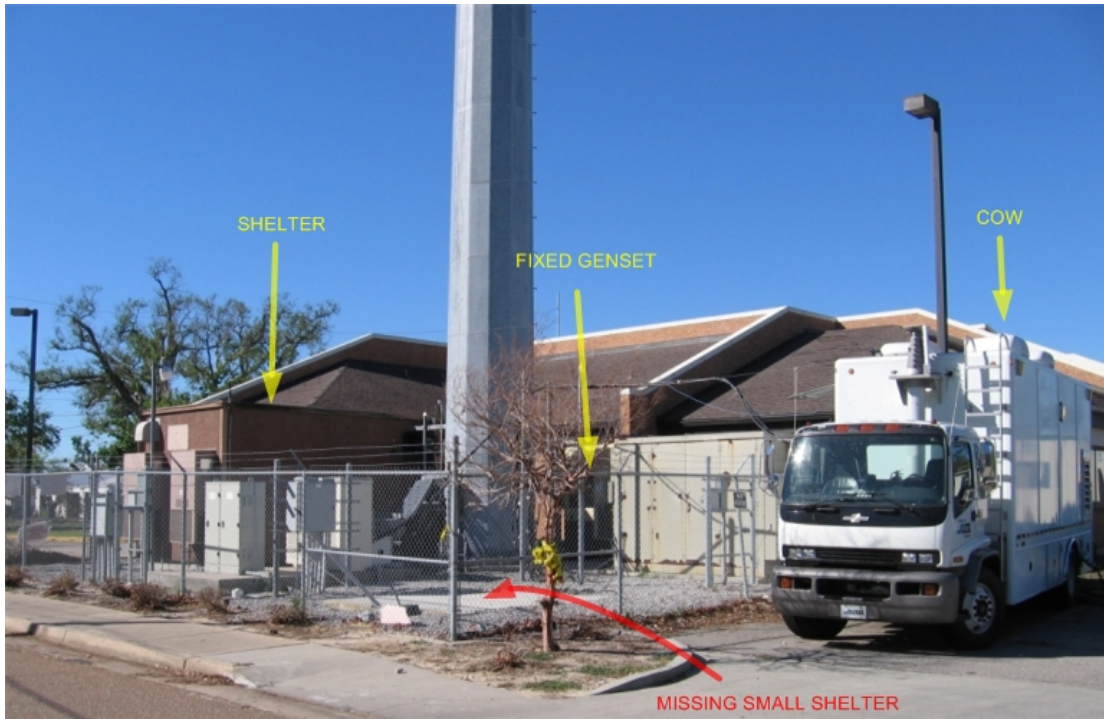
Fig. 6.30. Cell site in Biloxi showing a COW and a missing small shelter

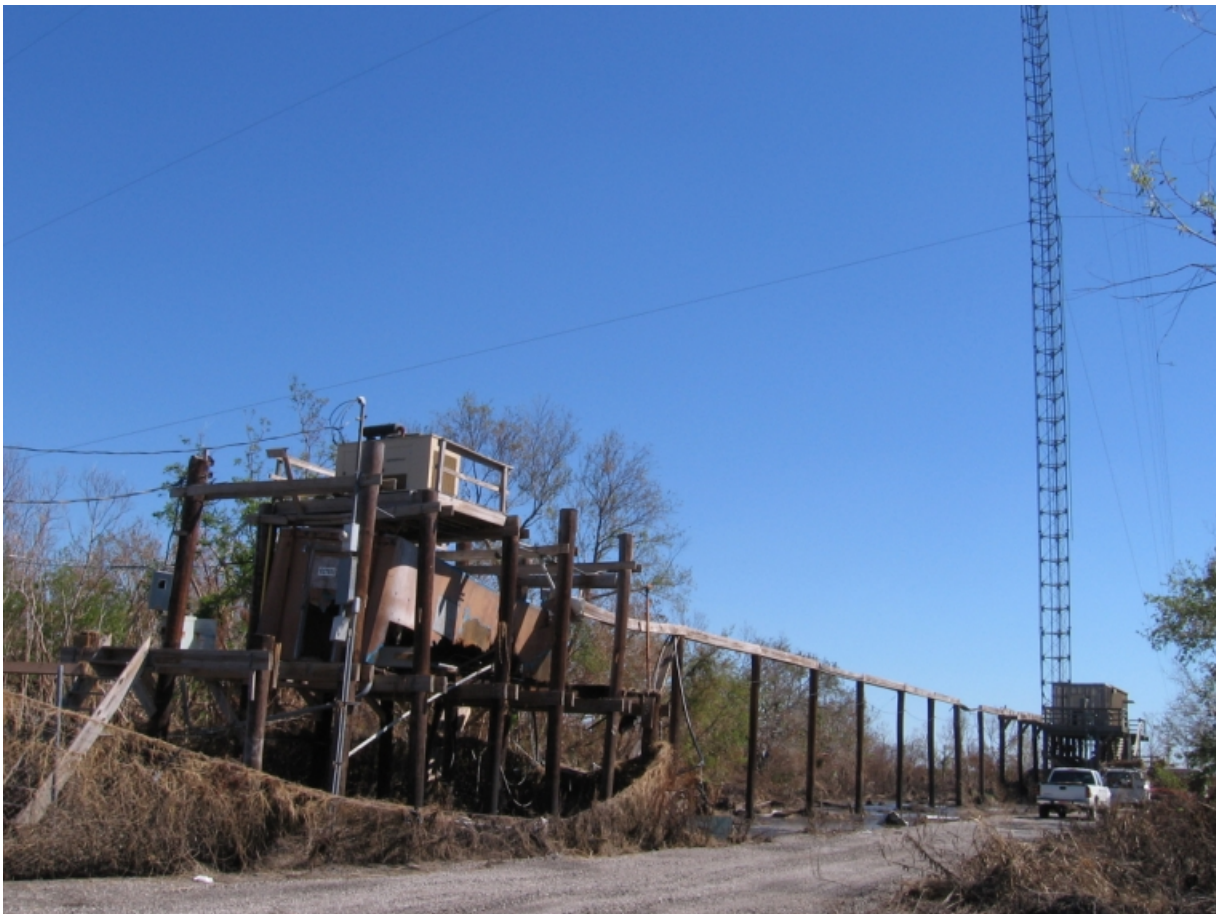
Fig. 7.1. KQLD-FM Radio transmitter and tower in Delacroix, LA

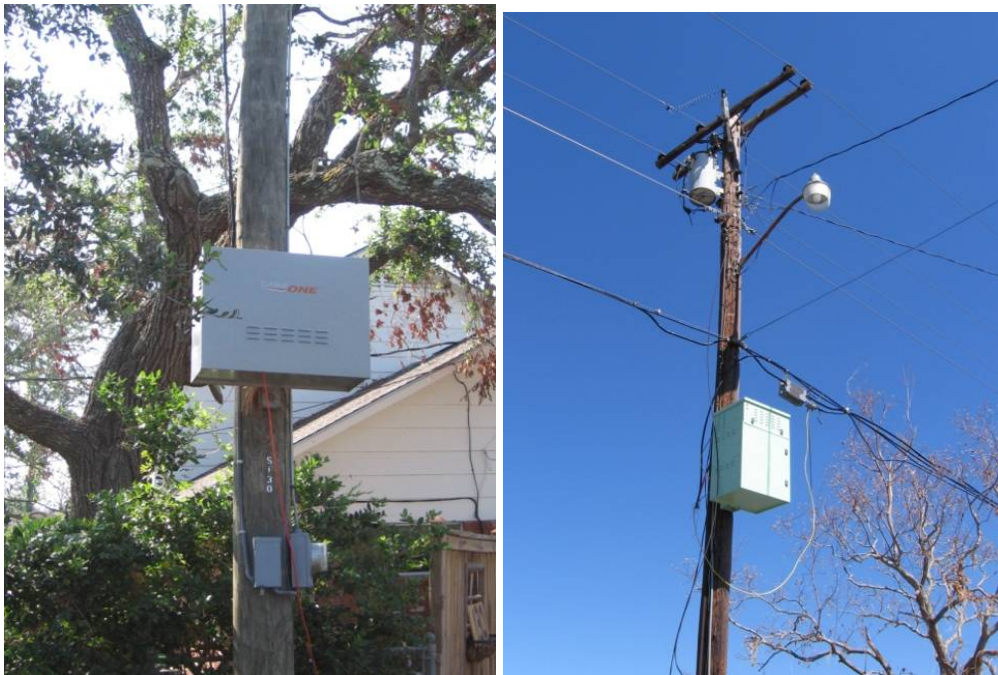
Fig. 7.10. Pole-mounted CATV UPS

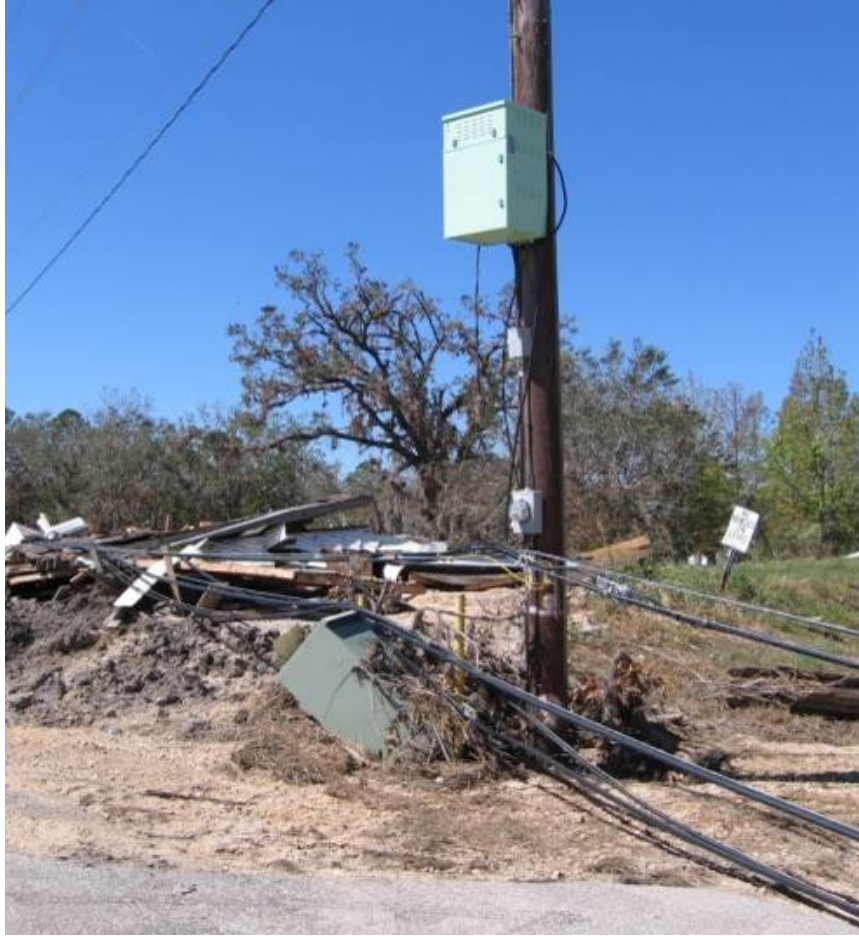
Fig. 7.11. Pole-mounted and pedestal-mounted CATV UPSs.

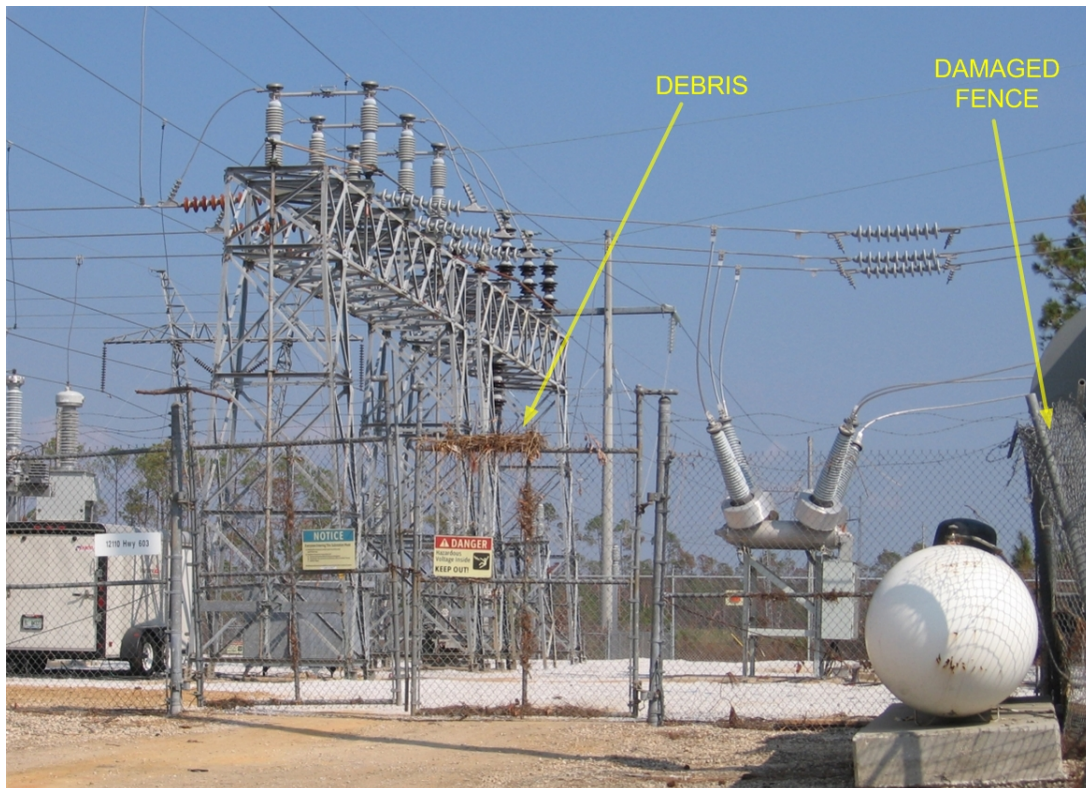
Fig. 8.5. Damaged substation on Route 603, northwest of Waveland, MS
