Case Study on a Polar DC Generator running more  
than 30,000 hours continuously

Site name: Comic Con North

Product description: -48 V, 10 kW Diesel DC Generator

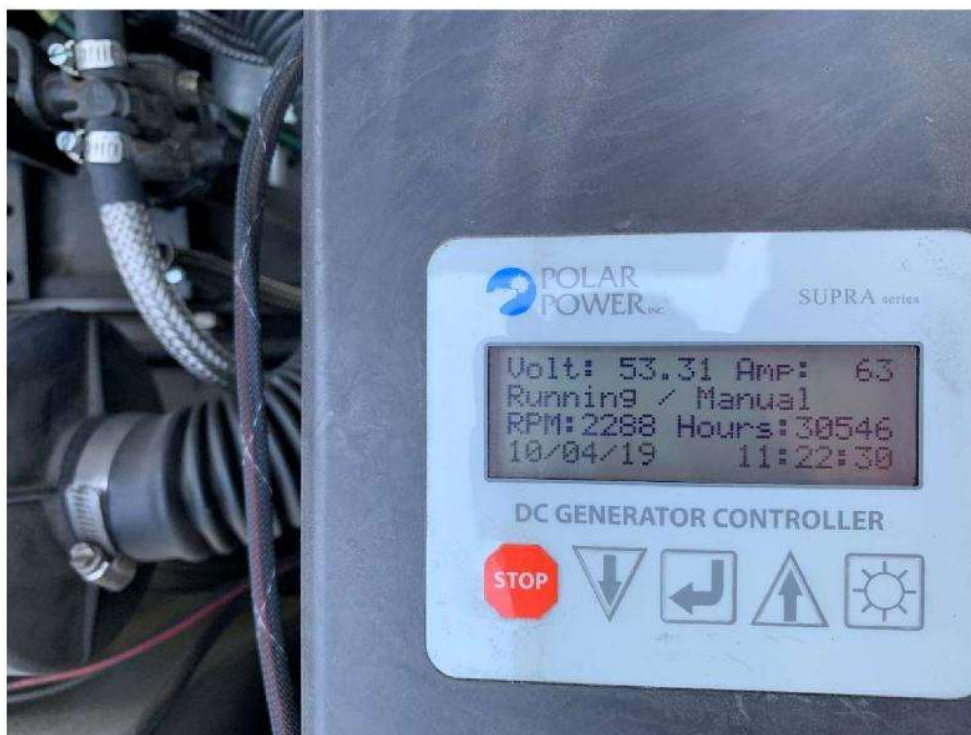
Generator continuous run hours: 30,546 and continuing

Results from past 4 years were taken as part of this study at this site with a continuous generator run time of over 30,546 hours and continuing. There were no failures from any critical components in the generator like the alternator, controller, engine, radiator, or the modems. There are no apparent issues that might indicate that an engine overhaul or replacement may be necessary.
