## Service Bulletin No 001A

### Stuck fuel level float.

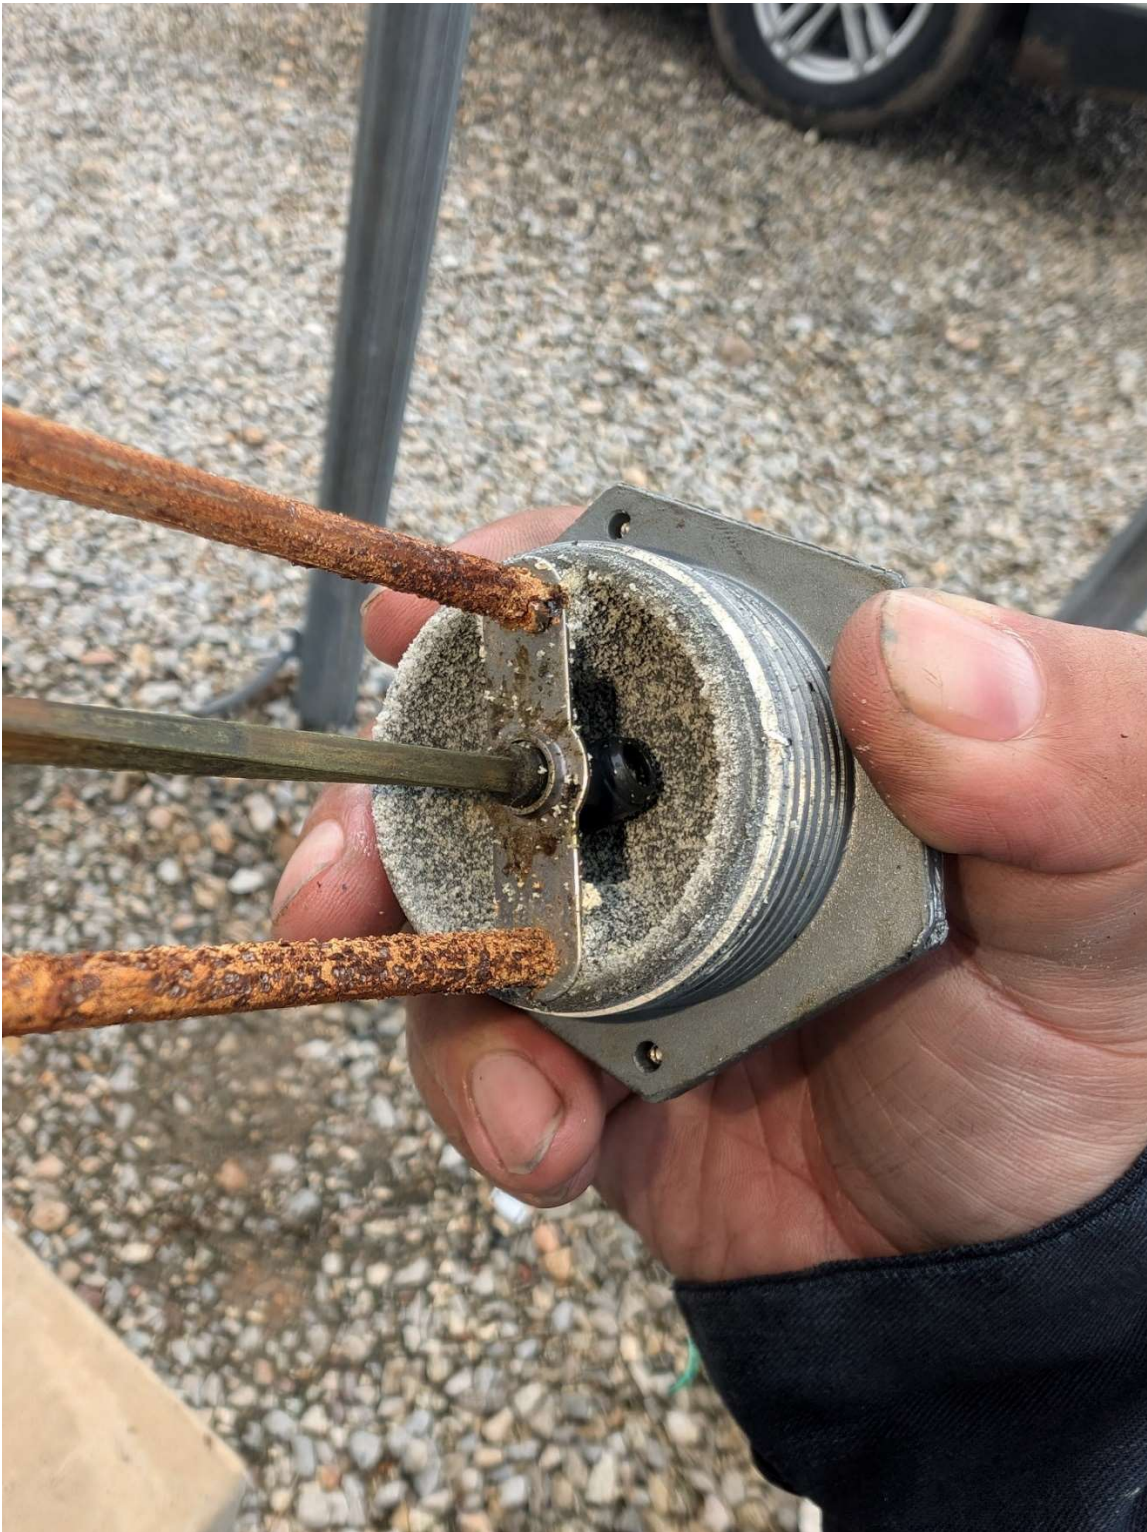
See the corrosion caused by the diesel on the aluminum fitting, the two outer steel rods, and the single center brass rod.

Without accurate information on the level of fuel in the tank, running out of fuel is common result. Improperly maintained diesel fuel will cause corrosion inside the tank including the rails that guide the float. Excessive tank corrosion should be an indicator to clean the float assembly, see photos.

An upgrade kit will be available (for reasonable charge) to change out the float to the solid state gauge.

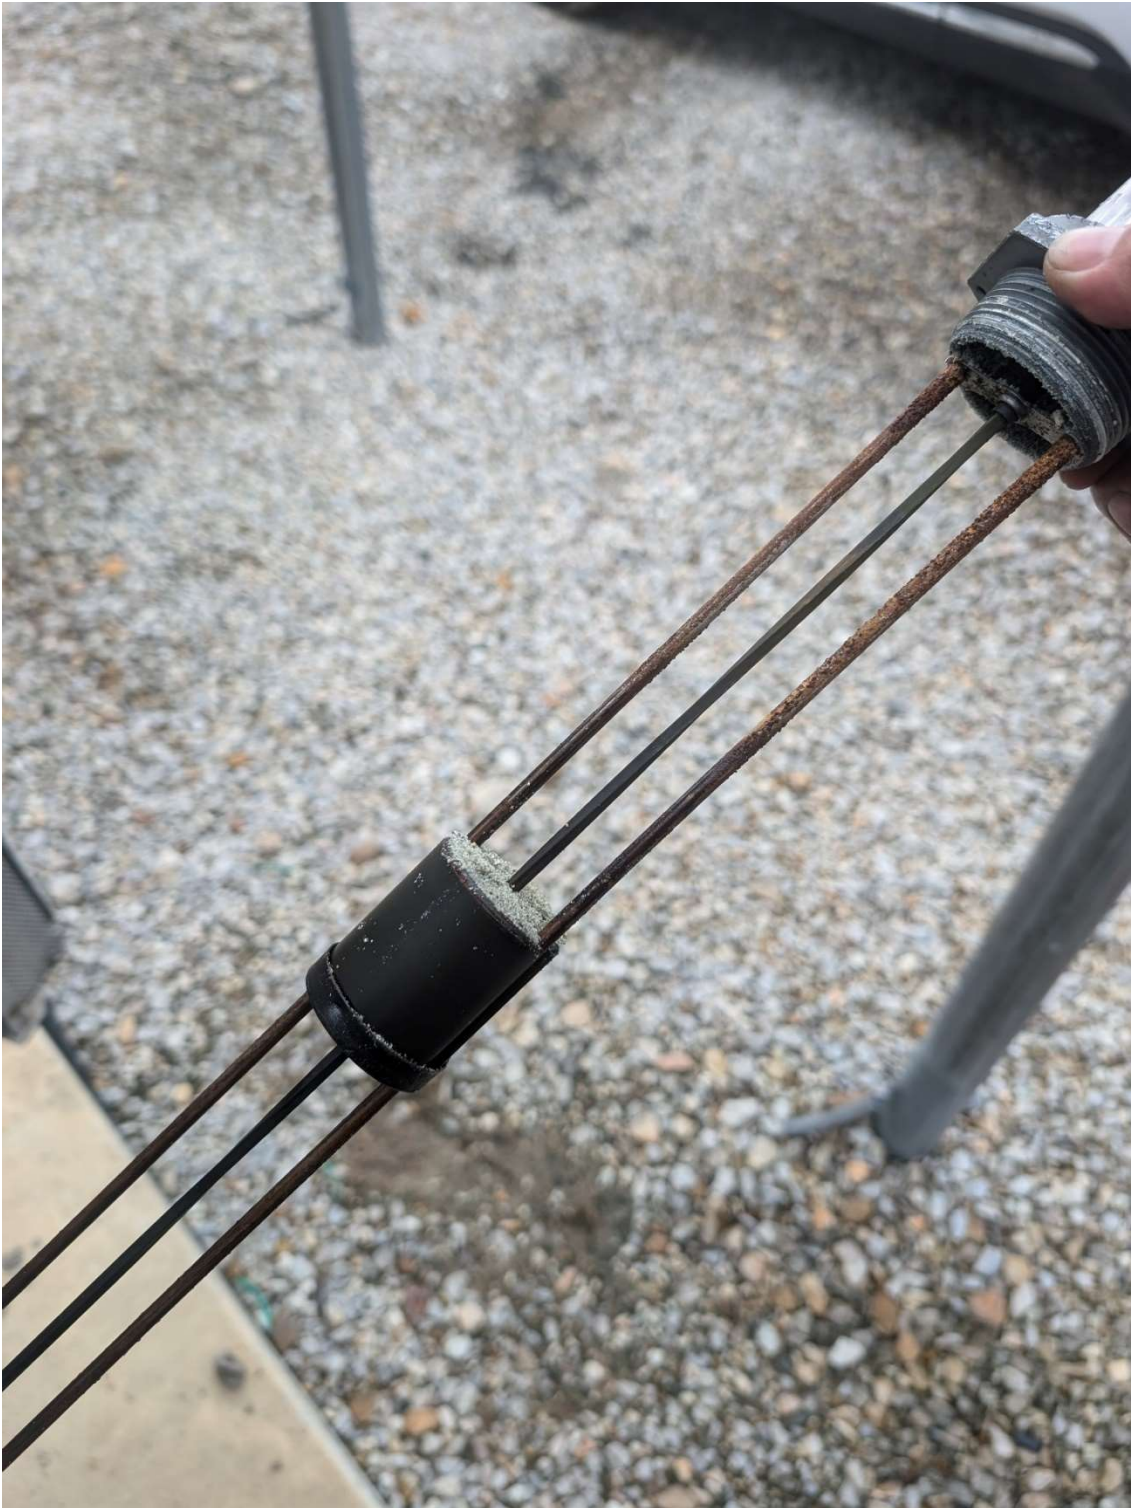
In the center of the photo is the brass float turned black in from the diesel and some material formed on top of the float, possibly aluminum corrosion falling from the cap or substance formed from the biodiesel?
